Southern Pacific
Transportation Company

TRAIN INSPECTION

FROM AN
AUDIO-VISUAL
SLIDE-SOUND PROGRAM

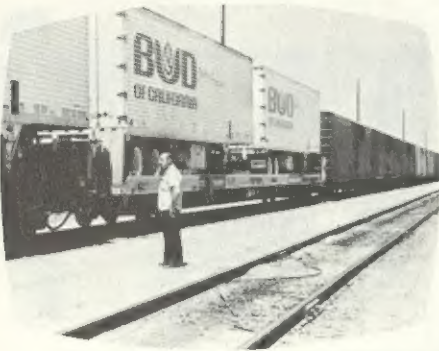
At all stops, a walking inspection of running gear, bearings, brake and draft rigging, and lading must be made on your train as often as practicable, as called for in Rules 827 and 829.

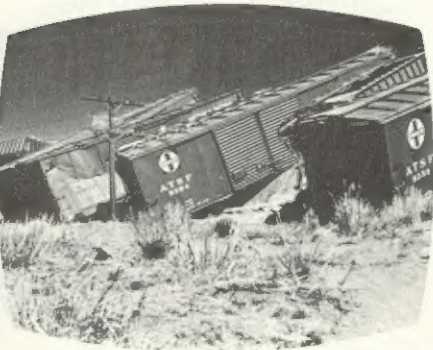
A derailment such as this could result in serious injury or possible loss of life and cost millions of dollars.

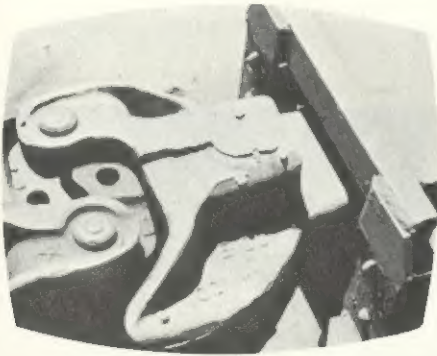
The coupler undergoes a great deal of strain in normal operations. This cracked coupler head could fail completely. A car with a cracked coupler head such as this should be set out.

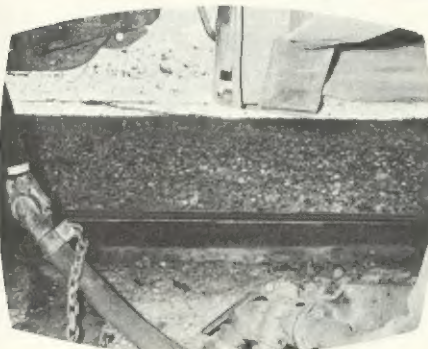
This would cause the angle cock bracket to drop from the coupler head.

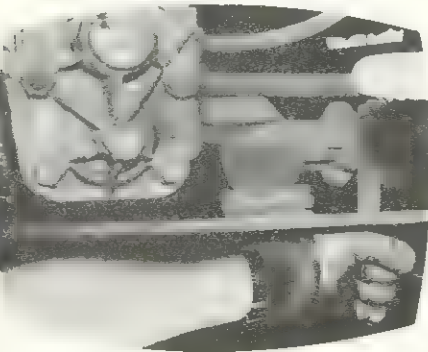
To cut out the air, turn the cut-out cock handle.

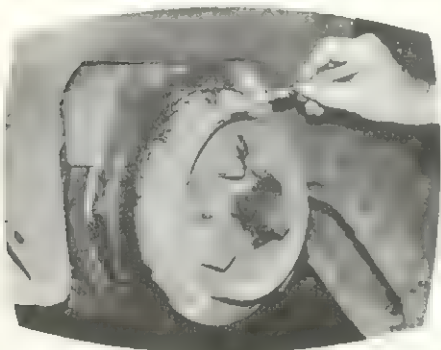
Check for excessive grease leaks on the bearings. Use a tempil stick on the roller bearing adapter for the heat test.

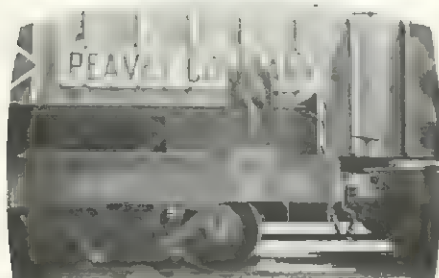
Develop a keen eye. This car is twelve inches off center. If you suspect a car is off center, . . .

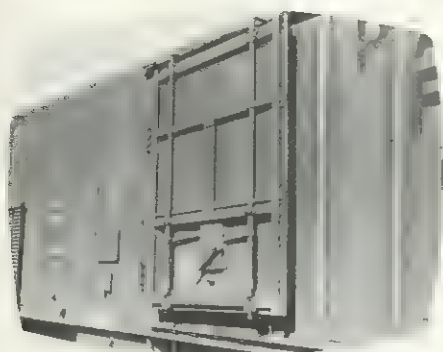
If the door is partially out of the top retainer, . . . set the car out as soon as possible. Notify all concerned personnel as to the condition of the unsecured door.

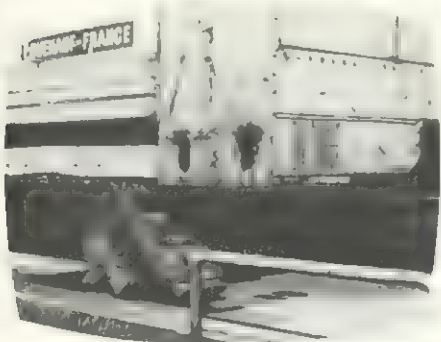
This container has completely moved out of the lock and is resting on the locking device. This car must be set out.

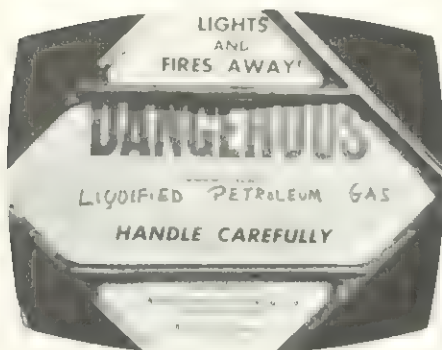
. . . flammable, poisonous, or otherwise hazardous must be given careful inspection at all points where train inspection is made. Conductors and trainmen must know their placement in the train.

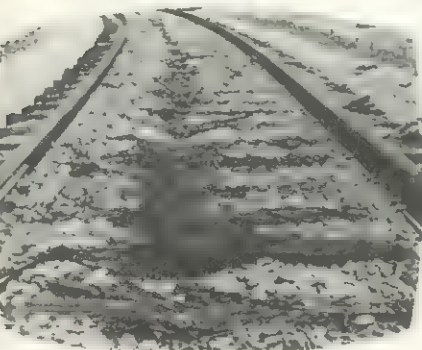
A crew member must inspect the track and structures behind the train to look for marked-up track, damaged structures, or cross ties. If fresh marks are found, the cause must be determined before proceeding, as this is an indication of derailment or dragging equipment.

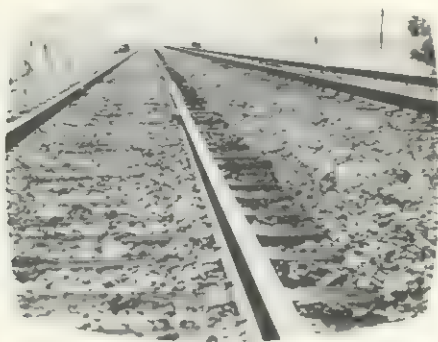
Also, if rough spots, broken rail; or other defects to track or roadbed are noted that will interfere with the safe passage of trains at normal speed, they must be reported to the dispatcher. If train dispatcher cannot afford protection, the train crew must do so.

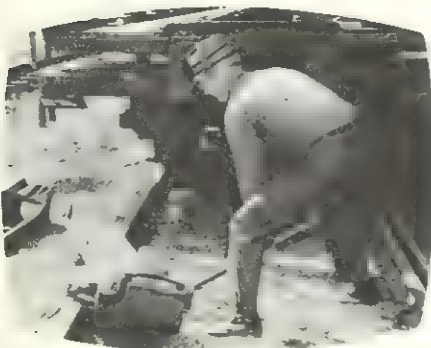
If a drawbar is pulled from a train...before proceeding, locate the missing part and remove it. It could cause a derailment if left between the rails.

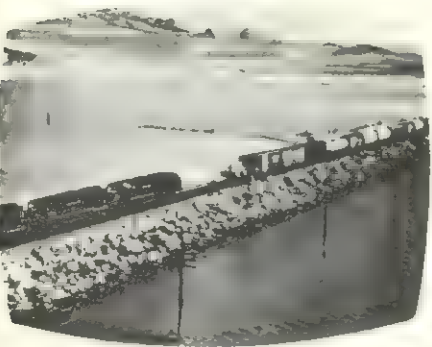
Plugs are carried in the caboose or are a part of the number eight vent valve, as shown here.

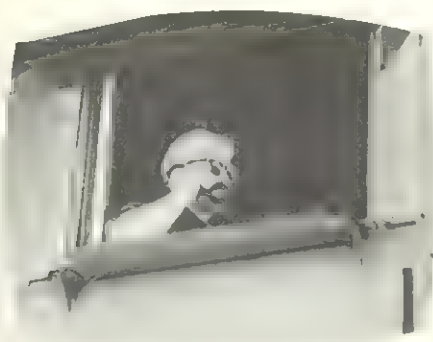
When on train and passing over dragging equipment detectors, . . .

. . . engine and train crews must communicate to each other the exact location of these detectors and be on the alert for any indication of dragging equipment. The engineer must inform the conductor when the train is approaching a hot box detector.

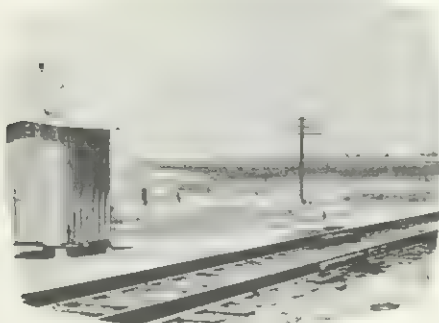
On a Type B detector,. . .
